Aftermarket Part Quality: A Report on Parts that Fail CAPA's Certification Requirements

Study Dates: March 1999 – May 2003

Certified Automotive Parts Association
1518 K Street NW, Suite 306
Washington, DC 20005

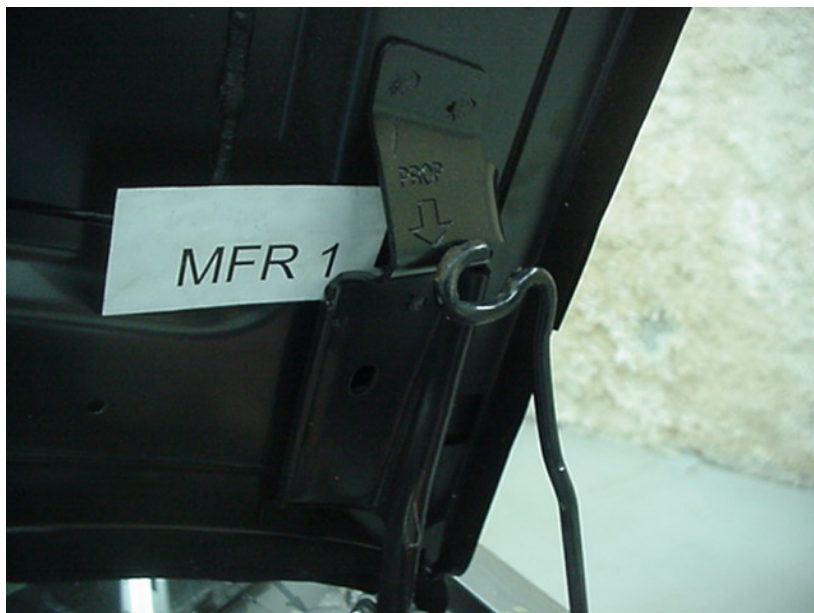
1. COMMON HOOD DEFECTS ON NON-CERTIFIED PARTS:

- Strikers incorrectly positioned so that the hood cannot be closed.
- Hinges shaped so that hood can't be opened far enough to be able to insert the prop rod.
- Parts with missing seam sealer.

Faulty hinge prevents hood rod from safely engaging.

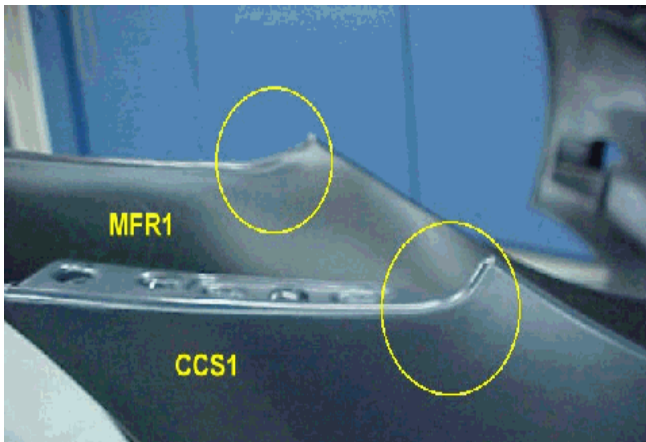
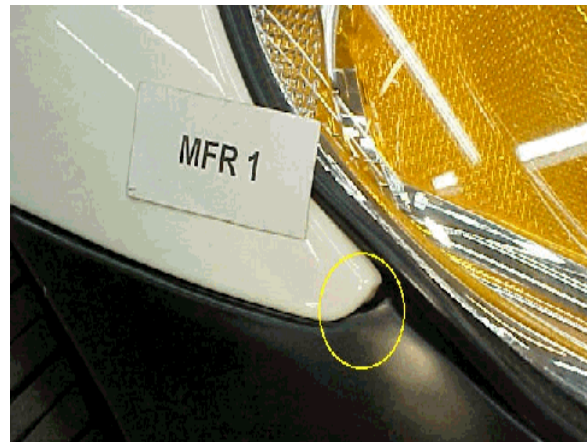
2. COMMON BUMPER COVER DEFECTS ON NON-CERTIFIED PARTS:

- Upper corners of front bumper cover incorrectly shaped, creating a gap between the cover and the fender where there should be none.
- Mounting clips can't be installed due to non-uniform trimming and excess material.
- Mounting area construction unlike car company service part, resulting in assorted fit defects, plus difficult installation.
- Mounting holes in wrong locations.

The shape of the corner is different than the car company service part and car company original part, which causes a gap between the cover and the fender where there should be none.

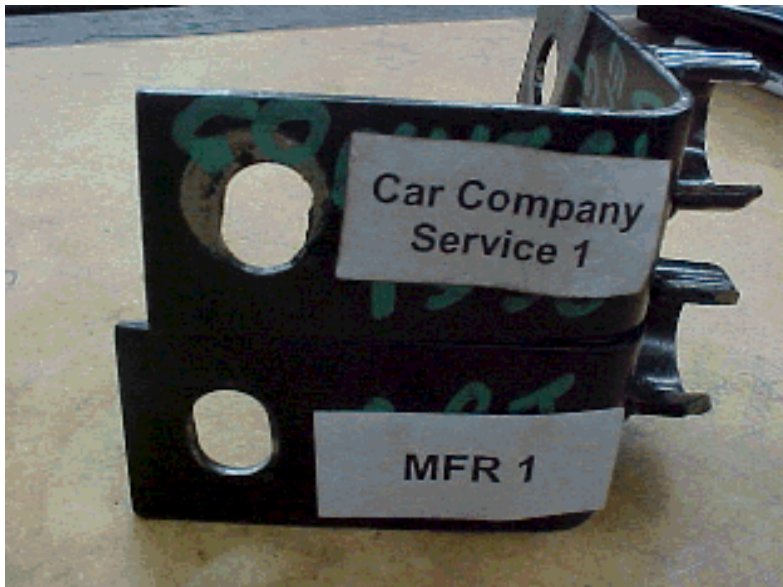
3. COMMON TAILGATE DEFECTS ON NON-CERTIFIED PARTS:

- Tailgate hinge bracket (passenger side) incorrectly shaped; parts could not be mounted.
- Latch lock mounting holes in wrong location; the locking mechanism could not be installed.
- Latching mechanisms that do not fully engage the latch lock; tailgate will not unlatch when closed.

Faulty hinge bracket prevents tailgate from being installed.

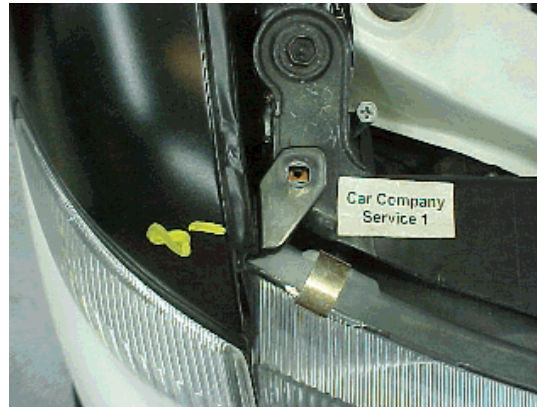
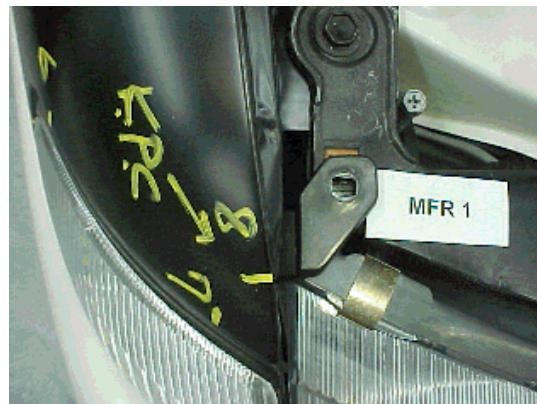
4. COMMON FENDER DEFECTS ON NON-CERTIFIED PARTS:

- Mounting weldments incorrectly positioned, which caused numerous gap and flush problems.
- Excess material cuts into front bumper cover.
- Incorrectly shaped critical areas create problems in fitting adjacent parts.

Non-certified AM fender incorrectly shaped/constructed. Corner lamp cannot be mounted.
