# **Car Company Quality: A Vehicle Test Fit Study of 1,907 Car Company Service Parts**

**Study Dates: March 1999 – March 2002**

Certified Automotive Parts Association  
1518 K Street NW, Suite 306  
Washington, DC 20005

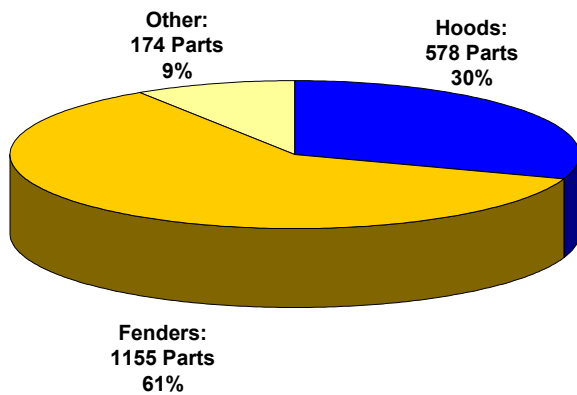
**CHART 1**  
**CAR COMPANY PART TYPES**  
**INCLUDED IN STUDY**  
**(1,907 PARTS)**

“Other” includes part types such as tailgates and bumper covers.

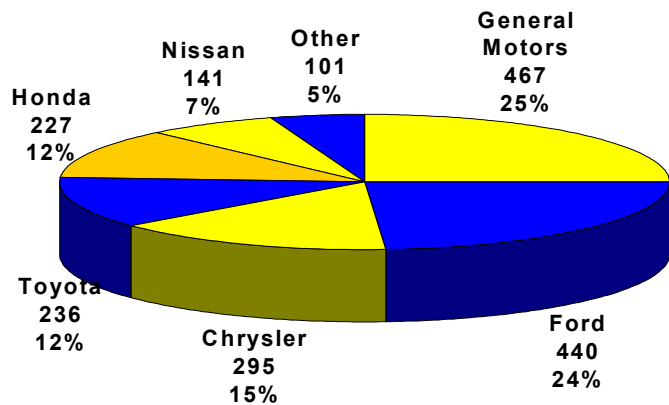
**CHART 2**  
**CAR COMPANY MANUFACTURERS**  
**INCLUDED IN STUDY**  
**(1,907 PARTS)**

“Other” car company manufacturers include BMW, Isuzu, Mazda, Mercedes, Mitsubishi, Suzuki, and Volkswagen.

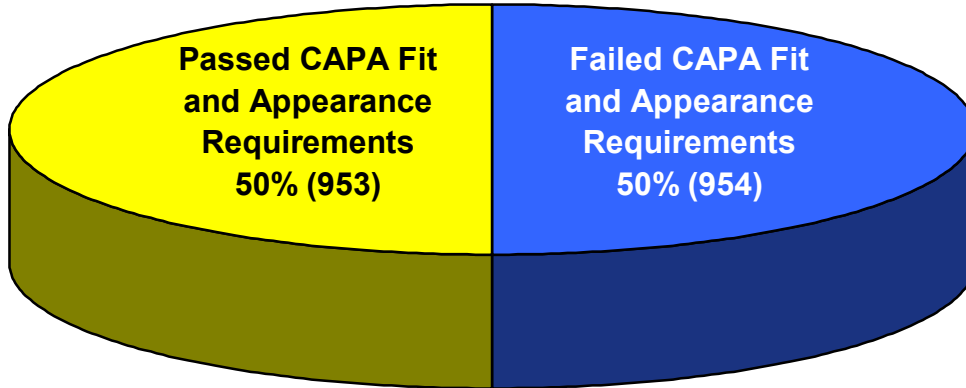
**CHART 3  
OVERALL RESULTS  
CAR COMPANY SERVICE PART QUALITY STUDY  
(1,907 PARTS)**

<u>Overall Summary</u>	<u># of Parts</u>	<u>% of Total</u>
Fail	954	50%
Pass	953	50%
Total Car Company Parts Evaluated	1,907

<u>Failure Types</u>	<u># of Parts</u>	<u>% of Failures</u>
Total Parts Failed*	954	
Fit	511	54%
Appearance	673	71%

\*Parts can fail both Fit and Appearance.

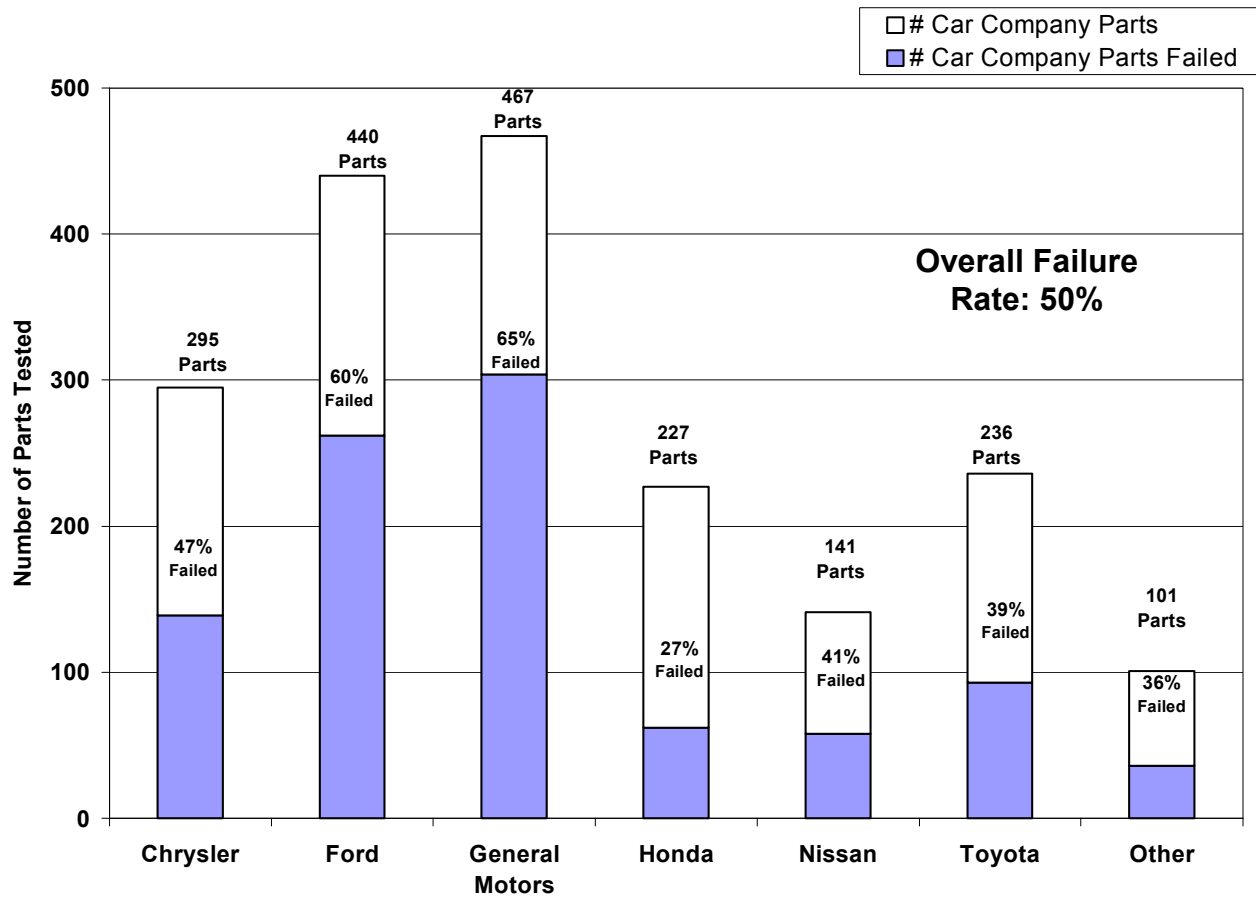
**CHART 4**  
**CAR COMPANY FAILURE RATES**  
**BY MANUFACTURER**  
**(1,907 PARTS)**

“Other” car company manufacturers include BMW, Isuzu, Mazda, Mercedes, Mitsubishi, Suzuki, and Volkswagen.

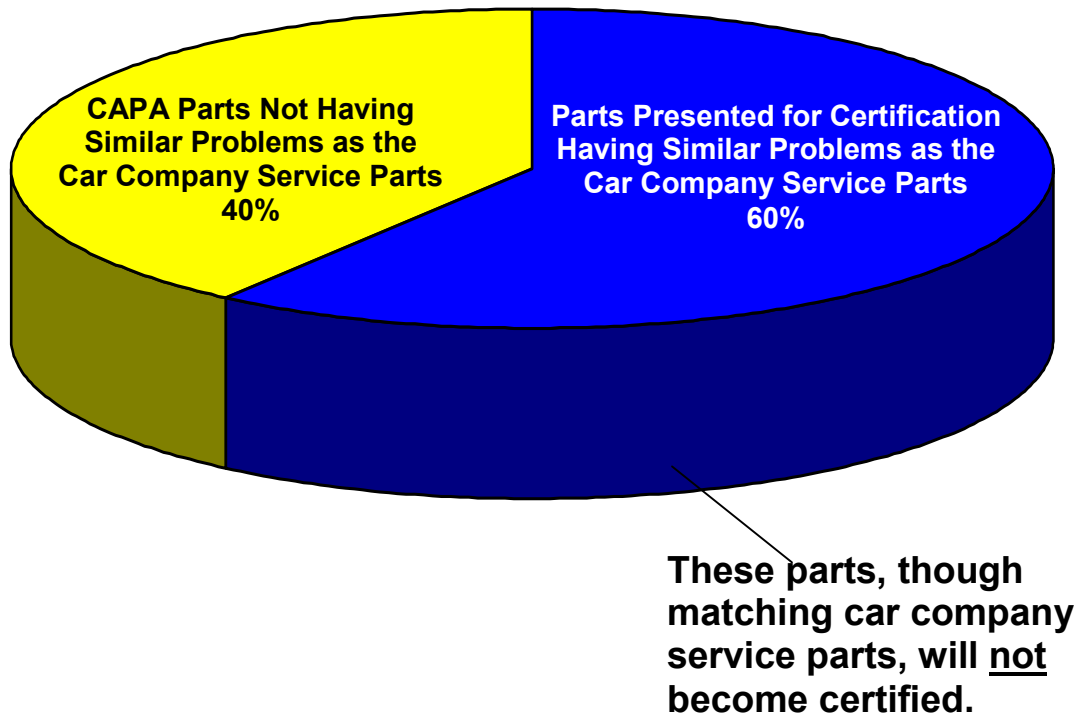
When a CAPA manufacturer develops a new part using car company service parts that have fit problems, it is probable that the competitive part will exhibit a similar problem. This is why the CAPA program mandates the Vehicle Test Fit.

If the part presented for certification does have a fit problem, the manufacturer must correct it prior to certification. While these parts technically match the car company parts, because they don't fit, they cannot become certified.

**CHART 5**  
**FIT DEFECTS IN CAR COMPANY SERVICE PARTS THAT ARE OBSERVED IN PARTS APPLYING FOR CAPA CERTIFICATION**

In reality, while the CAPA parts matched their car company service counterparts, at times they were not fitting the vehicles for which they were intended. The reason: significant inconsistencies in the car company service parts. Reverse engineering duplicates everything, including defects that may not appear until the part is mounted on a vehicle. A defect in a car company service part that was copied in a CAPA part is referred to as a "follow-through" defect. (See Chart 5.)

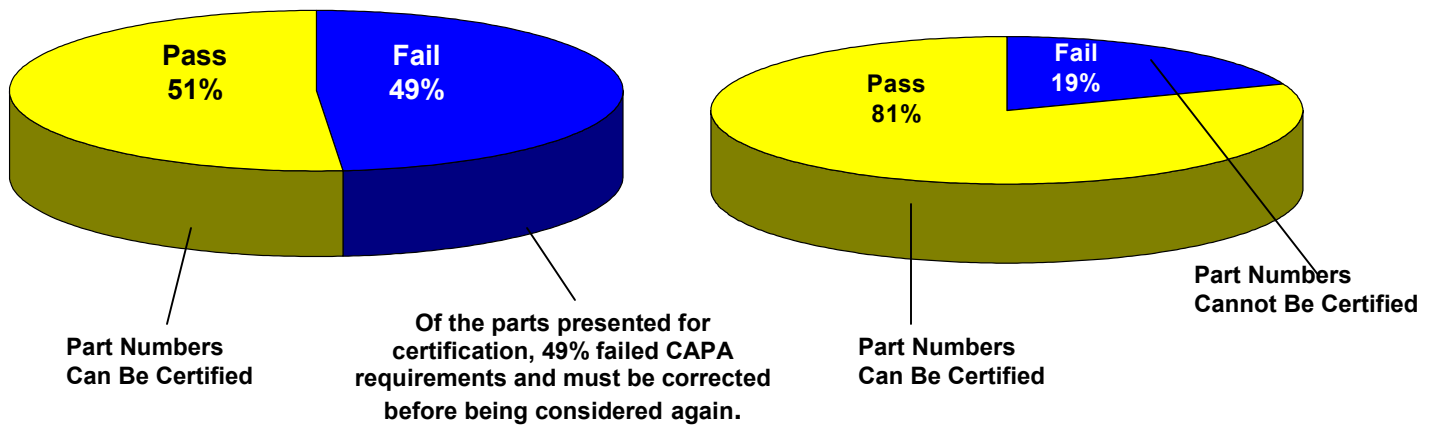
Of the 49% of parts that failed on the first test, 62% were resubmitted. Of those, 81% passed. Overall 76% of CAPA parts presented became certified.

**CHART 6**  
**VEHICLE TEST FIT RESULTS**  
**PRELIMINARY AND SUBSEQUENT RETESTS**
